DEPARTMENT OF TRANSPORTATION

Quality Assurance and Source Inspection

Contract #: 04-0120F4Cty: SF/ALA Rte: 80 PM: 13.2/13.9File #: 69.28**WELDING INSPECTION REPORT****Resident Engineer:**Pursell, Gary**Address:** 333 Burma Road**City:** Oakland, CA 94607**Report No:** WIR-008920**Date Inspected:** 16-Sep-2009**Project Name:** SAS Superstructure**OSM Arrival Time:** 700**Prime Contractor:** American Bridge/Fluor Enterprises, a JV**OSM Departure Time:** 1900**Contractor:** Zhenhua Port Machinery Company, Ltd (ZPMC), Changxing Island **Location:** Shanghai, China**CWI Name:** Chen Xi**CWI Present:** Yes No**Inspected CWI report:** Yes No N/A**Rod Oven in Use:** Yes No N/A**Electrode to specification:** Yes No N/A**Weld Procedures Followed:** Yes No N/A**Qualified Welders:** Yes No N/A**Verified Joint Fit-up:** Yes No N/A**Approved Drawings:** Yes No N/A**Approved WPS:** Yes No N/A**Delayed / Cancelled:** Yes No N/A**Bridge No:** 34-0006**Component:** OBG Crossbeams**Summary of Items Observed:**

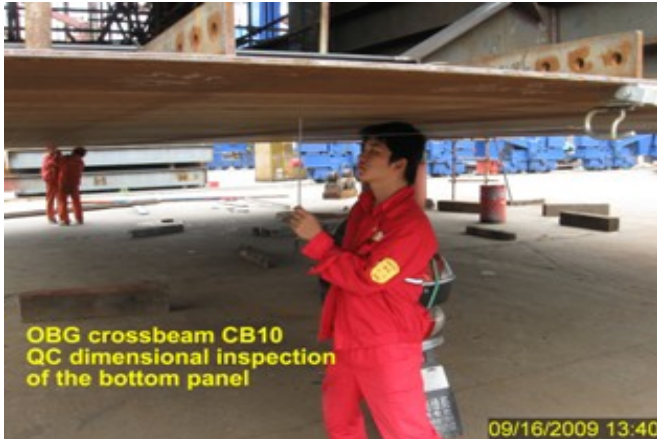
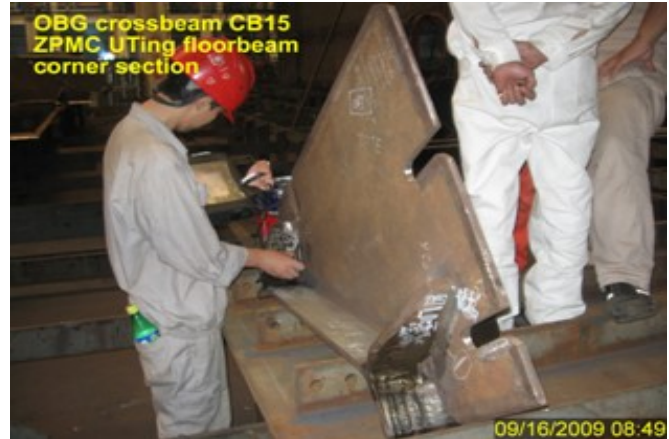
This QA observed ZPMC personnel fitting floor beam sections to the side panels of this crossbeam. This QA also observed ZPMC QC Ultrasonic Testing (UT) technician performing first time repair (R1) UT on several of the crossbeam floor beam corner sections. QA observed that the technician appeared to have rejected the following previously repaired welds: FB204-047-025, 028 and 031, FB204-046-021, FB204-045-021, FB204-046-040 and 046, FB204-045-024 and FB204-045-046. This QA observed that the technician did not appear to be indicating on the material that the R1 repairs were rejected. This QA requested that he mark the welds as R1 rejected on the material near the applicable welds in accordance with the contract documents. The technician complied with QAs request.
